## Phase IA Archaeological Survey Quinnipiac River Trail Meriden, Connecticut

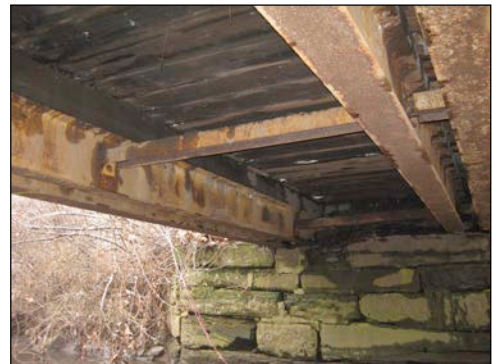
*Former I-beam railroad bridge.*

The former railroad bridge consisted of paired I-beam stringers set atop brownstone abutments, to which had been added a modern plank decking and railings. Because it represented a common type of construction with little engineering significance and had been altered in appearance, it was not recommended as eligible for the National Register of Historic Places. No other bridges, culverts, rail-related buildings, or rail-related artifacts were observed during the walkover (the tracks had been torn up in 1924). Although the research indicated an ice house and rail siding within the project area, no evidence for either was observed in the field.

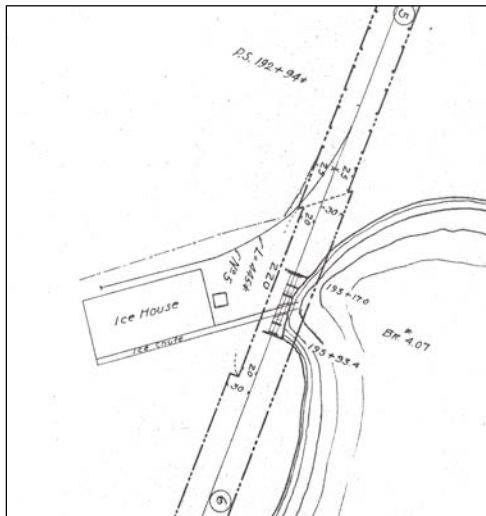
*The 1915 track map showed an ice house, ice chute, and rail siding adjacent to the track, but no evidence of these features was found during the walkover, and the ground appeared to have been substantially disturbed.*
